SNS RFQ Problem Findings and Recommendations

John Staples
13 October 2003

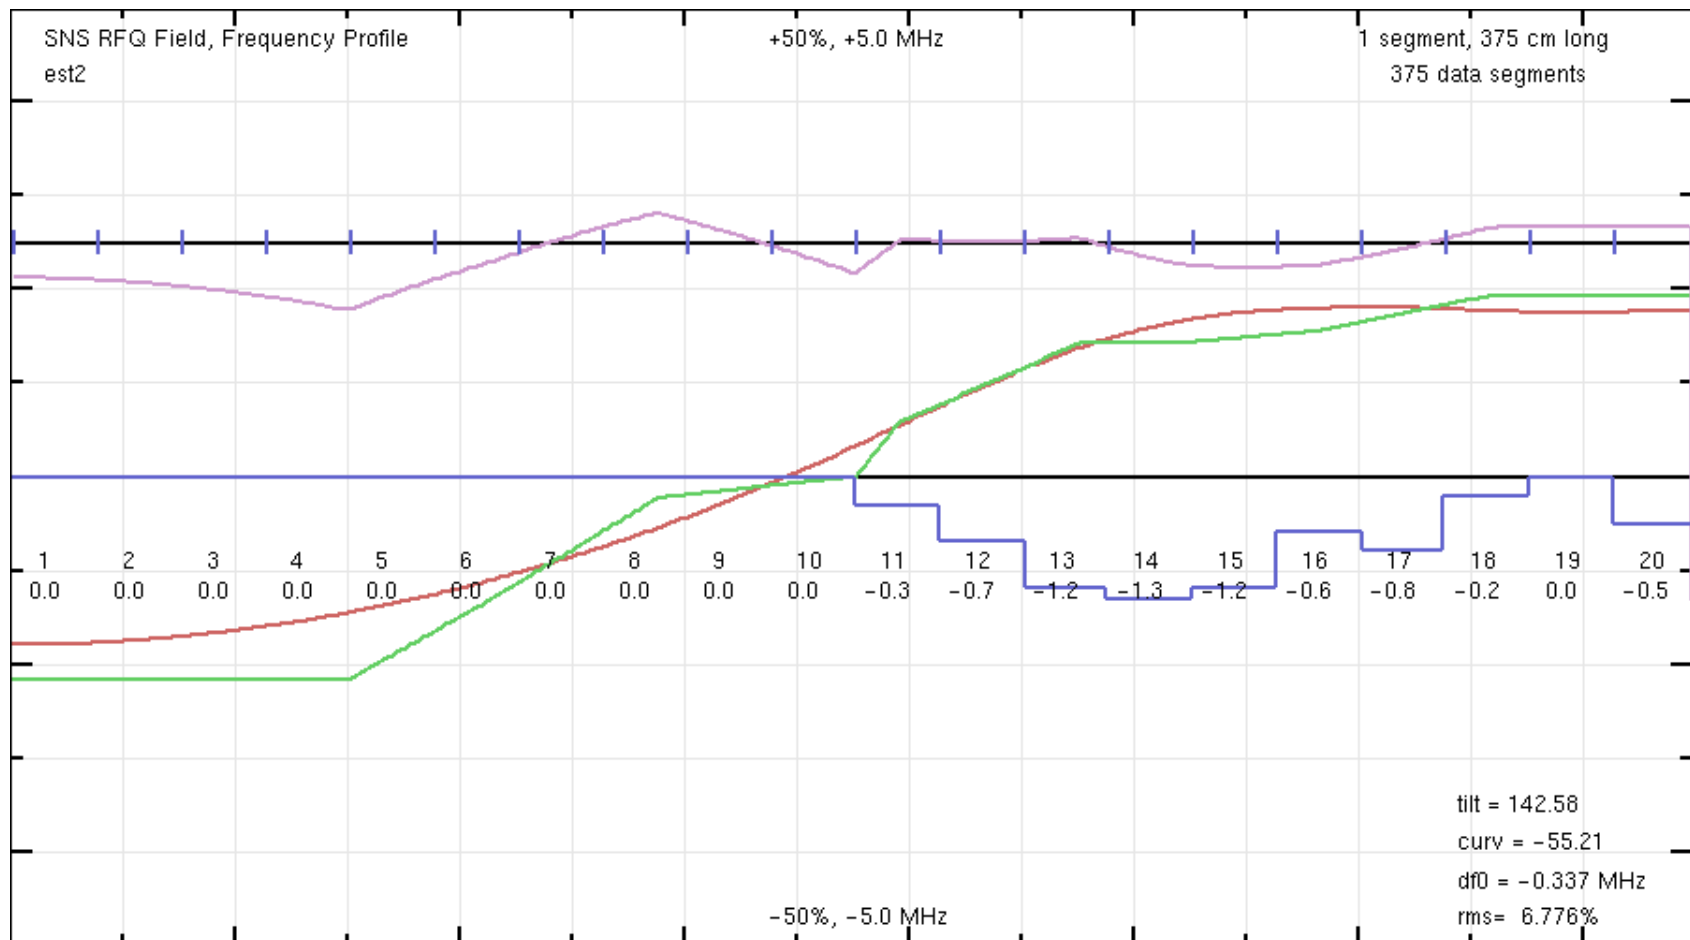
RFQtune Program

- Still don't know what happened during glitch
- Unable to do precise enough measurements of vane tip position
- Scans show problem centered in module 3
- All obvious candidates eliminated
- High-power operation already demonstrated

- Using scan data, calculate new tuner profile
 - Maximum tuner length change < 3 mm
 - About 1/3 of tuners need to be changed
 - Adjustable tuners arriving tomorrow
- ORNL people experts in tuning
- LBL people ready to come and help
- Beam dynamics will be revisited
